# Adhesion and Electromigration Performance of Barrier / Copper Interconnections in CMOS Technologies

**Nasim Naderseresht**

*NNIN REU Site: Stanford Nanofabrication Facility, Stanford University*

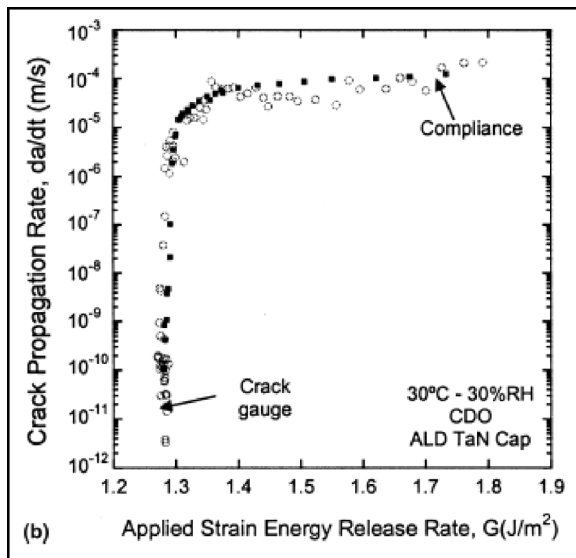
Figure 3: Previous results of our group measuring crack velocity versus adhesion without any current [3].

Figure 3 shows the results of previous work by our group [3]. This shows the relationship between crack velocity,  $v$ , versus the applied strain energy release rate,  $G$  (or driving force for cracking/debonding) for a copper/tantalum nitride interconnect without any current. In our present results, shown in Figure 4, we see  $v$ - $G$  curves for two control specimens and two specimens with different current flow,  $J$ . Negative  $J$  represents electrons flowing opposite to the crack growth direction and positive  $J$  represents electrons flowing along the crack growth direction. We can see that these current densities are  $\sim 2$  orders of magnitude below those used in standard electromigration tests, and there is no noticeable effect on crack growth at these low current densities.

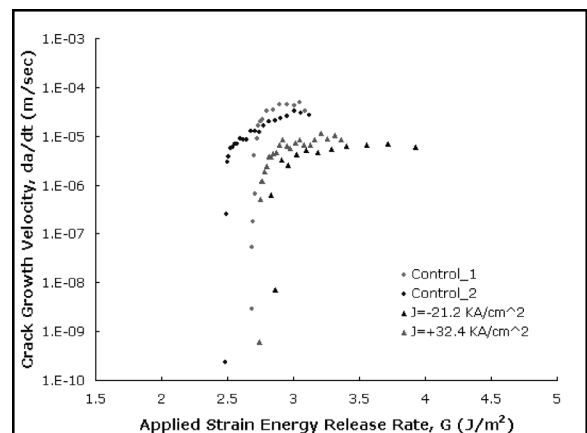
Figure 4, above:  $v$ - $G$  curves for this work for two current densities, showing little effect on crack growth.
