Adhesion and Electromigration Performance of Barrier / Copper Interconnections in CMOS Technologies

Nasim Naderseresht

NNIN REU Site: Stanford Nanofabrication Facility, Stanford University

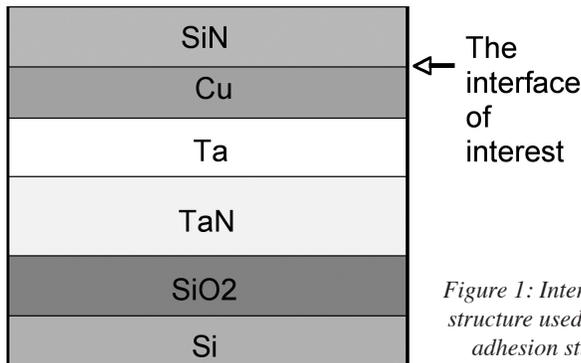
Samples were obtained of typical multilayer interconnect structures, as shown in Figure 1. Copper was the main conducting layer and silicon nitride (SiN) was the barrier layer on top. The SiN layer was etched off at the ends in order to make contact areas. 85% aqueous phosphoric acid at room temperature was used. The resistance was measured every 5 minutes until the SiN was removed.

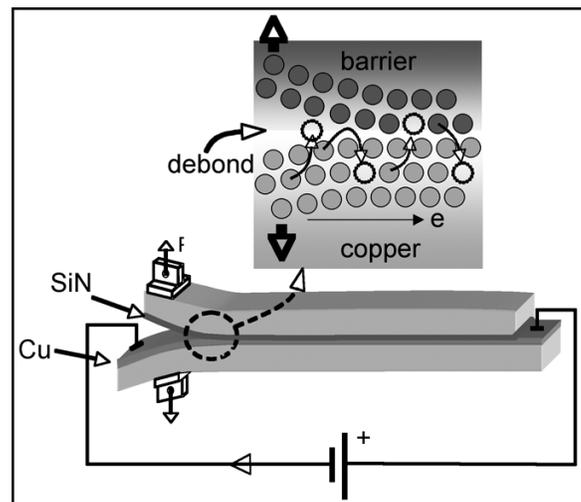
Figure 2: Schematic of samples used in standard subcritical double-cantilever beam fracture mechanics measurement, to measure crack velocity, v , versus adhesion, G , for different current densities.

As shown in the schematic diagram in Figure 2, the crack propagation rate or velocity, v , was measured versus applied

strain release rate, G (which is a measure of adhesion) by using standard subcritical double-cantilever beam fracture mechanics method. This was measured while different current densities were applied.

1a shows XPS results of the top fracture surface (in Figure 2), indicating it is indeed a SiN layer. Table 1b shows XPS results of the bottom fracture surface (in Figure 2), indicating it is, in fact, a copper layer. From these results, we can conclude that the crack is indeed growing between the layer of Cu and the layer of SiN.

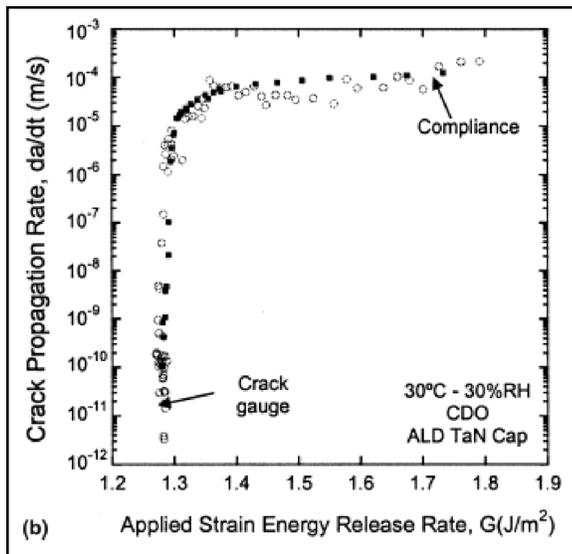
Figure 3: Previous results of our group measuring crack velocity versus adhesion without any current [3].

Figure 3 shows the results of previous work by our group [3]. This shows the relationship between crack velocity, *v*, versus the applied strain energy release rate, *G* (or driving force for cracking/debonding) for a copper/tantalum nitride interconnect without any current. In our present results, shown in Figure 4, we see *v*-*G* curves for two control specimens and two specimens with different current flow, *J*. Negative *J* represents electrons flowing opposite to the crack growth direction and positive *J* represents electrons flowing along the crack growth direction. We can see that these current densities are ~ 2 orders of magnitude below those used in standard electromigration tests, and there is no noticeable effect on crack growth at these low current densities.

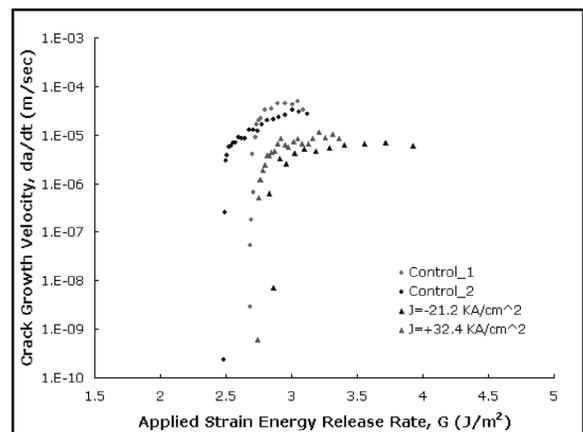
Figure 4, above: *v*-*G* curves for this work for two current densities, showing little effect on crack growth.
